SEWING TROUBLE and COUNTERMEASURE NEEDLE - CAR SEAT / LEATHER -

ORGAN NEEDLE CO., LTD.

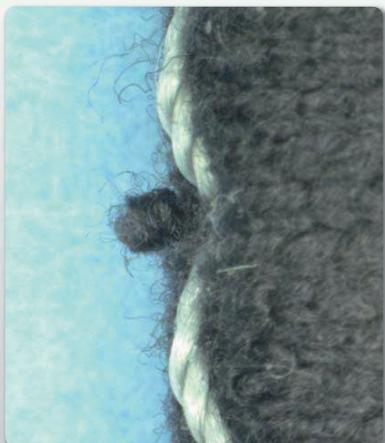
Fabric Yarn Breakage

TROUBLE

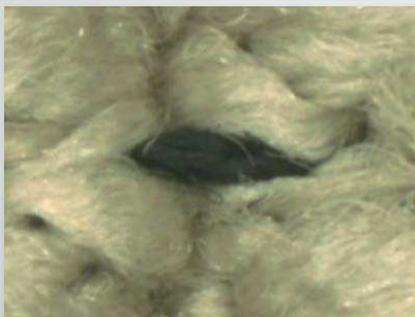
DP-N45 #18

COMPARATIVE PHOTOGRAPH

The DP-N45#18 is a countermeasure needle against Fabric Yarn Breakage when using DPX17. The incidence of Fabric Yarn Breakage is lower than with DPX17#16. However, it is as strong as DPX17#18.

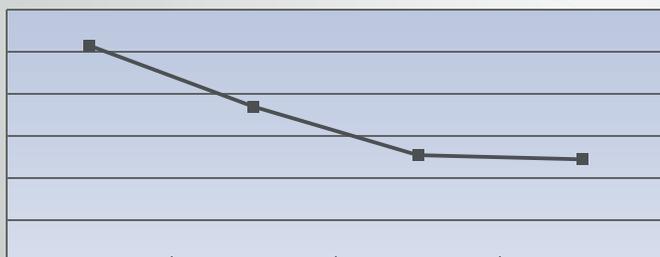
INCIDENCE OF FABRIC YARN BREAKAGE

DPX17 #19S DPX17 #18S DPX17 #16S DP-N45#18

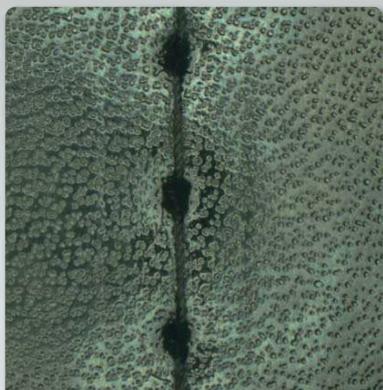
Regular

COMPARATIVE PHOTOGRAPH

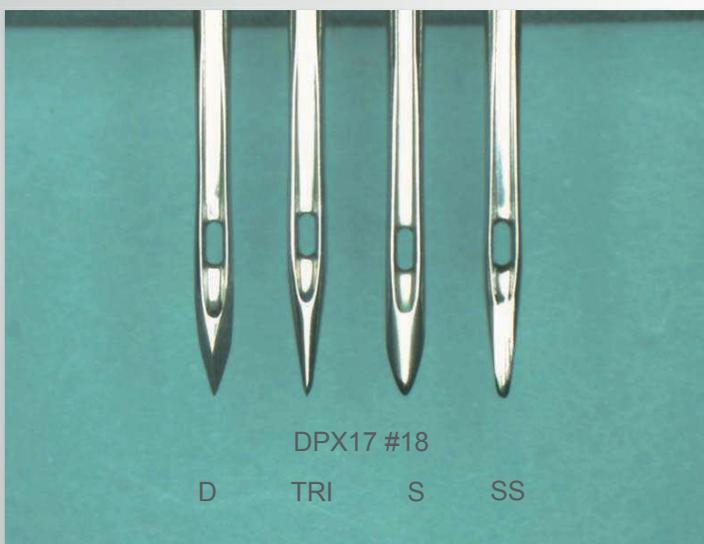
Cutting Point
(SS·TRI·PS)

SS,TRI,PS indicate additional options. The option code desired is inserted after the size number:DPX17 #19SS.

COMPARATIVE PHOTOGRAPH
